# **INFRASTRUCTURE MASTER PLAN 2019-2029**

## **PHASE 1 (WATER AND SANITATION)**

**MATJHABENG LOCAL MUNICIPALITY**

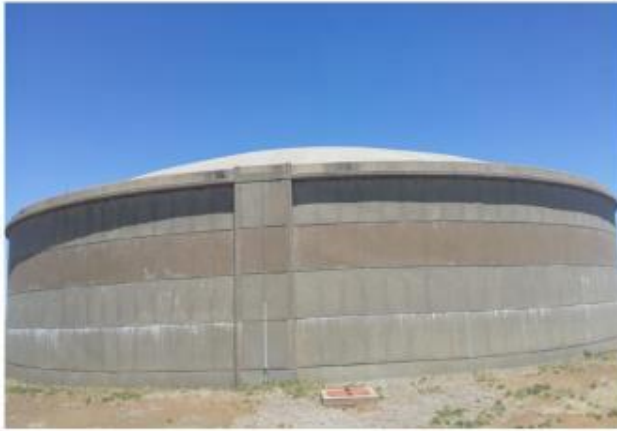
Ventersburg reservoir, no faults were found

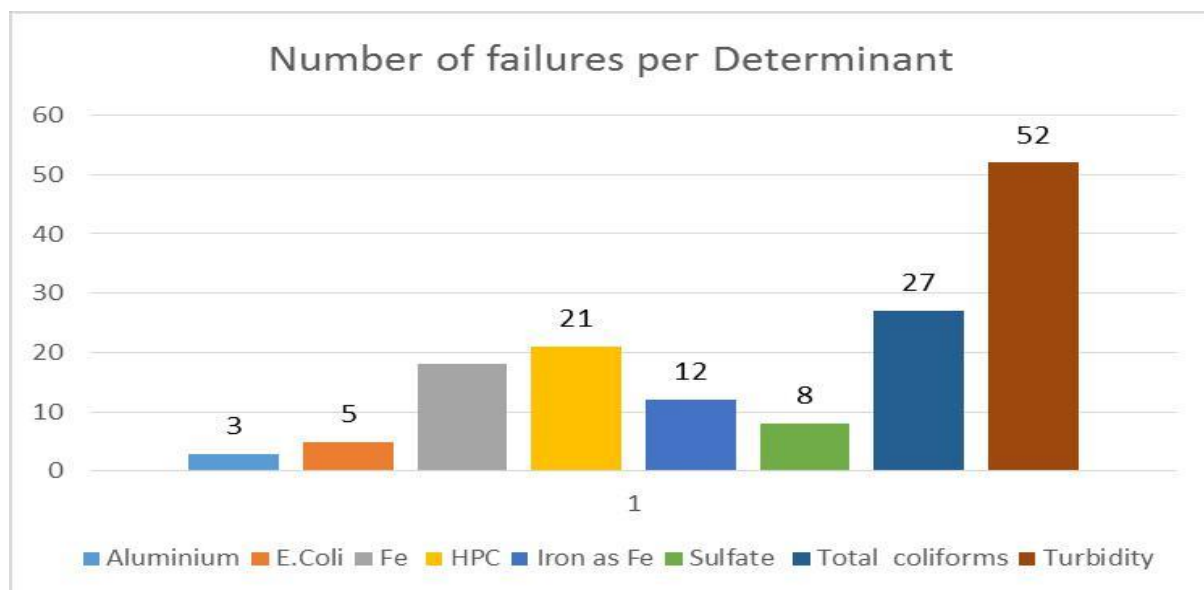
**Figure 4.2.1 : Number of failures per determinant**

**Figure 4.2.1** below shows the number of failures in the overall MLM network.

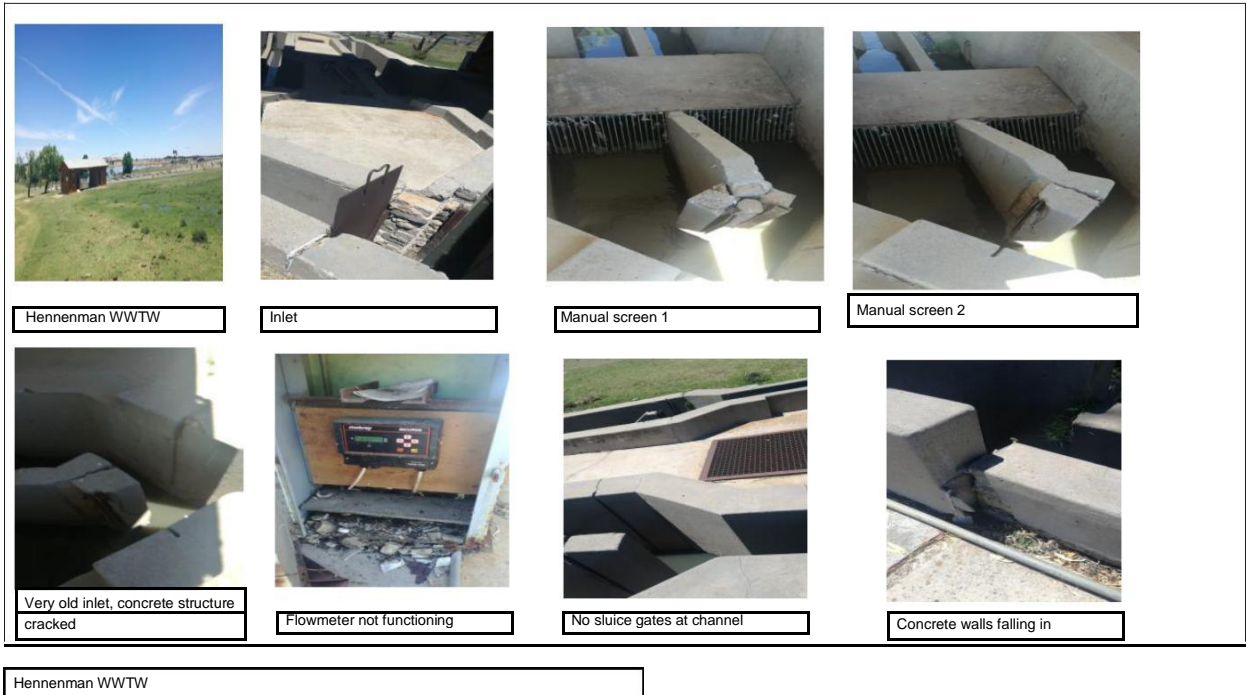
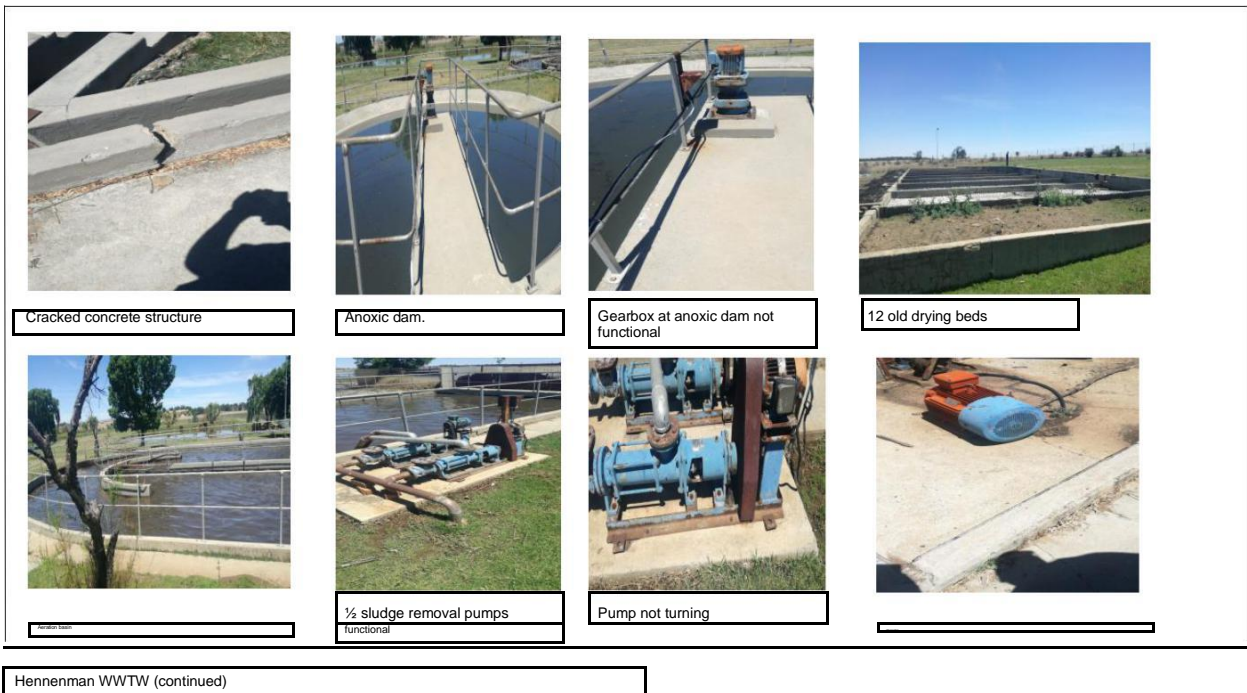
Brush aerator, motor not functional

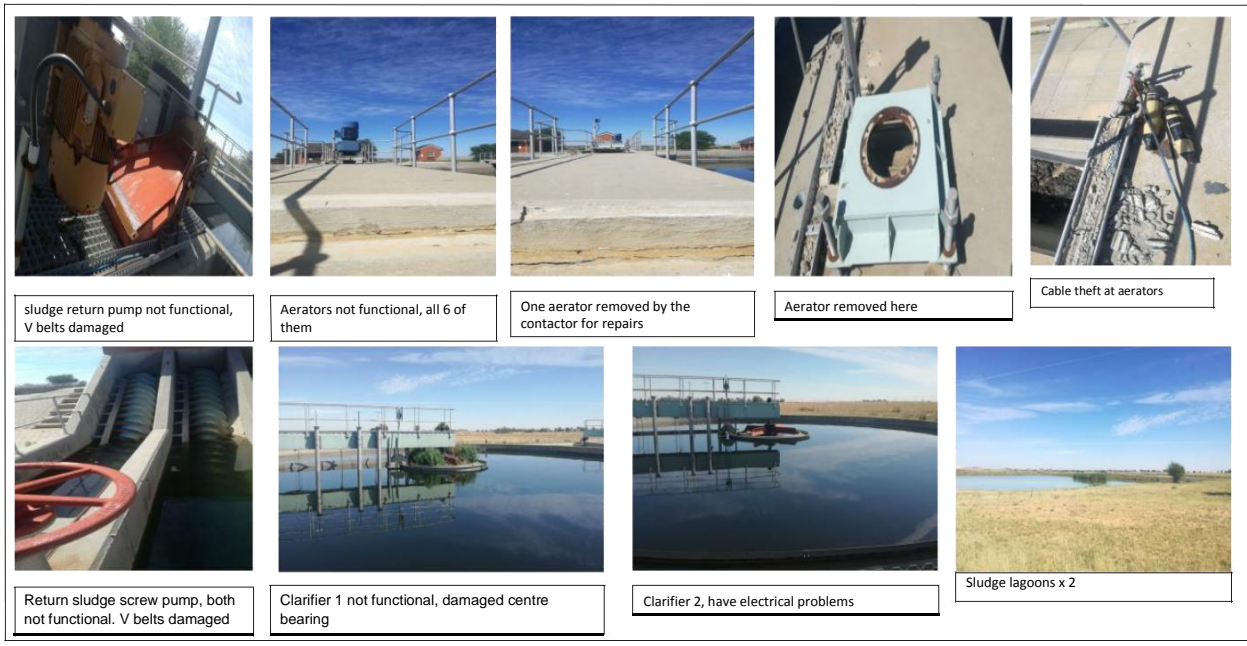
sludge return pump not functional, V belts damaged

Aerators not functional, all 6 of them

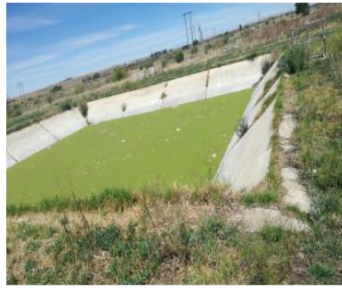
Anaerobic pond not operational

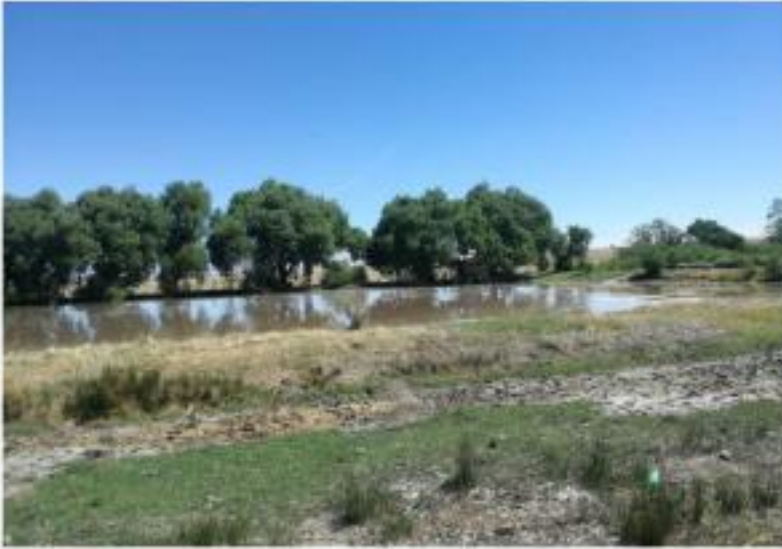
Ventersburg WWTW

Oxidation pond, self purification plant, only has 4 oxidation ponds. Pond contains blood from the abattoirs

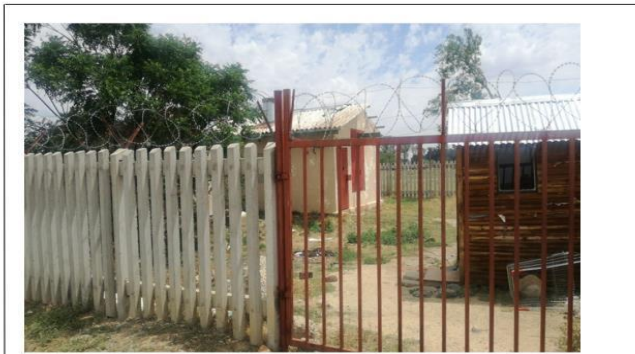
Gate and concrete palisade fence

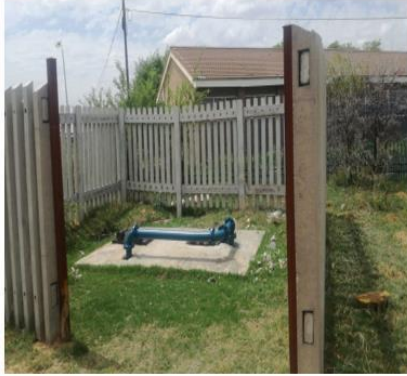
Eldorie Pump station, no gate

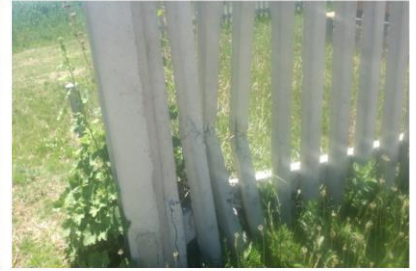
Broken concrete palisade fence

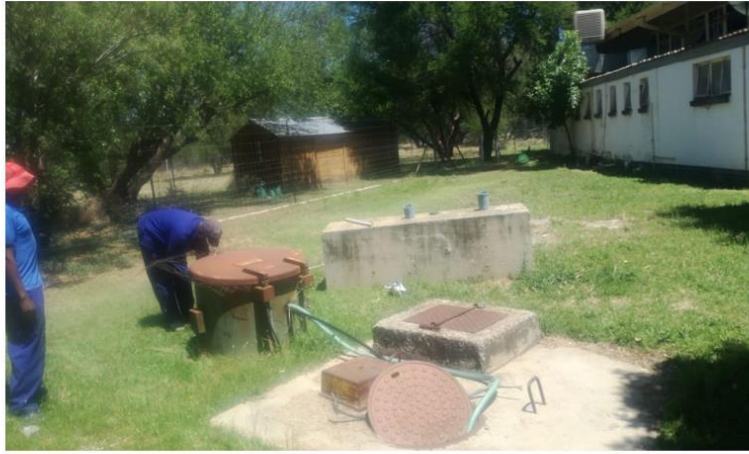
Duikboot Pump station

Pump station inside Tikwe lodge ,one pump functional.

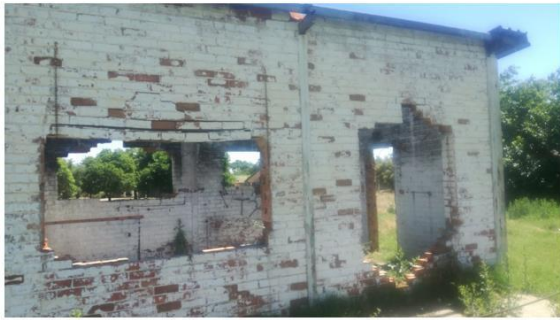
Completely vandalised

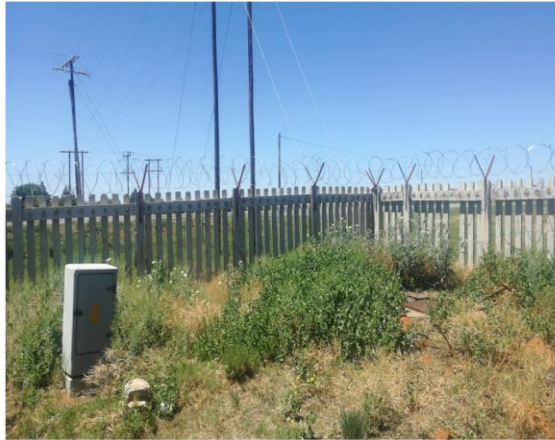
No power supply

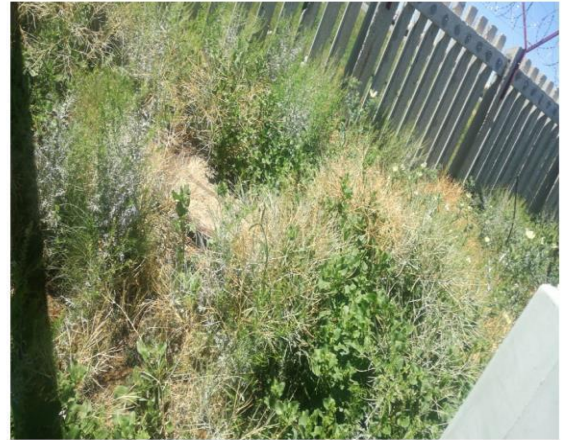
No pump, electrical cable removed by contractor during the nearby road construction and have not replaced it.

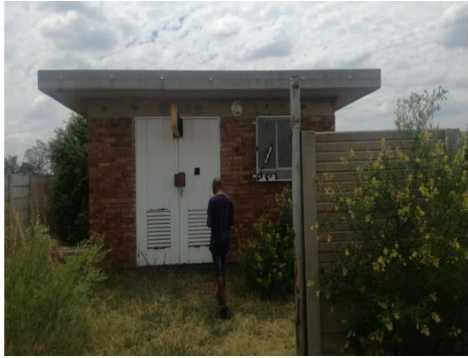
The pump station does not have a gate

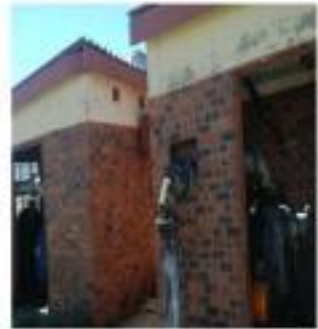
Buildings in poor condition.

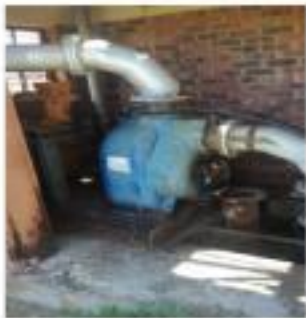
Pump 1 fully operational
