# **INFRASTRUCTURE MASTER PLAN 2019-2029**

## **PHASE 1 (WATER AND SANITATION)**

**MATJHABENG LOCAL MUNICIPALITY**

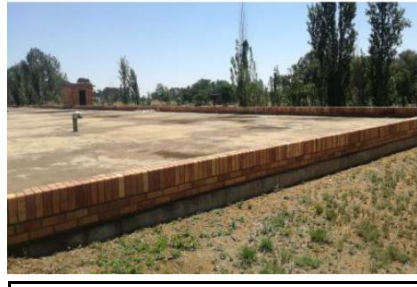
Allanridge reservoir, no issues

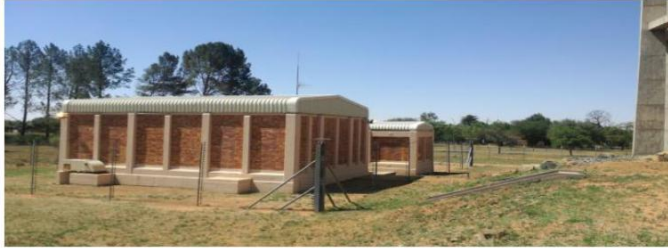
Pump station at Allanridge, pump working

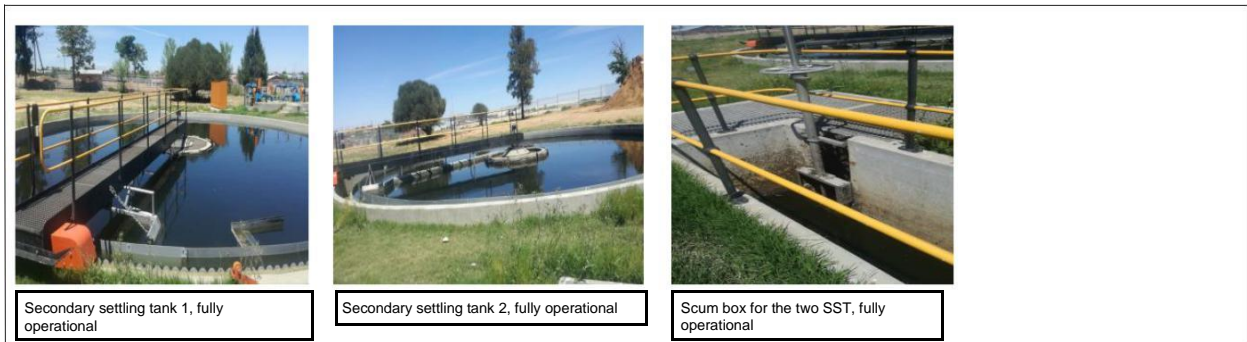
Nyakallong WWTW

Secondary Settler	humus tank		Y	1	Good,working
		clarifier		Y	2	Good,working
<b>TERTIARY TREATMENT PROCESS</b>	Disinfection (chemicl/UV)		Y	1	Good,working	
	Constructed Wetlands		N			
	Maturation pond/s		Y	1	Good,working	
<b>SLUDGE TREATMENT PROCESS</b>	Dewatering	filter/belt press		N		
		drying beds		N		
		gravity		Y	1	Good,working
	Thickening	dissolved air floatation		N		
	Digestion			Y	3	Good,working
<b>FACILITY FACILITIES</b>	Fence (steel palisade (SP)fence/concrete palisade(CP)/ brick wall (BW)/wire fence		Y		Concrete palisade,completely vandalised by Zamazamas	
	Lockable gate		N		Bad,no lockable gates	
	Electrified		N			
	Yard		Y		In bad condition	
	Staff facilities		Y		In bad condition	
	Sludge licence		N			
	Contract for sludge disposal		N			
<b>REMARKS</b>	Plant is operating very well and currently under refurbishment.

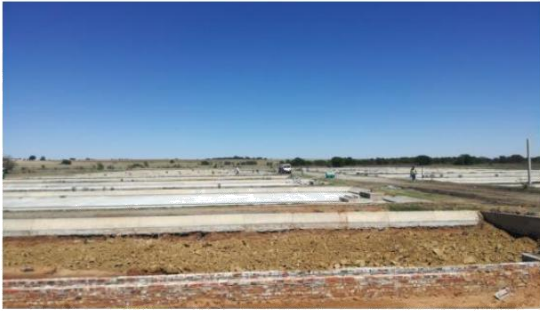
22 drying beds, currently under refurbishment

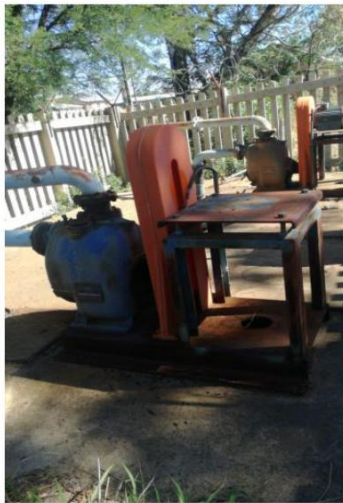
One pump does not have motor

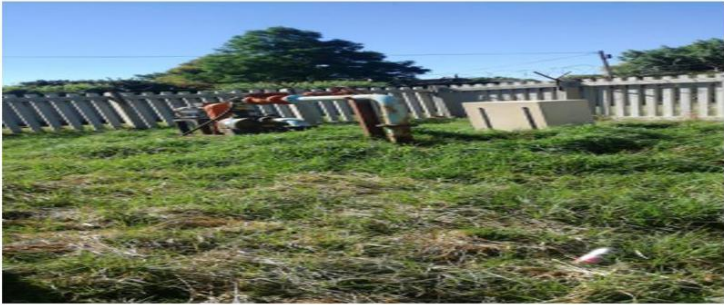
The pump is working

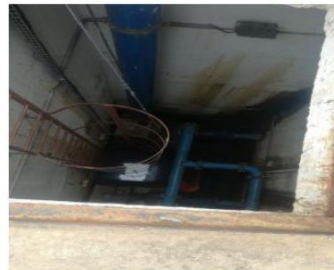
Two pumps only one pump working, the other one does not have a motor

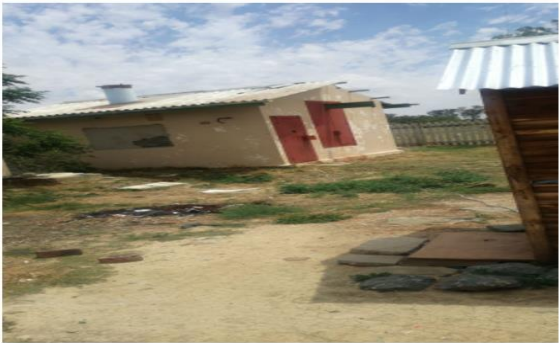
No keys to the gate, there are two pumps but only one working. The other pump does not have motors

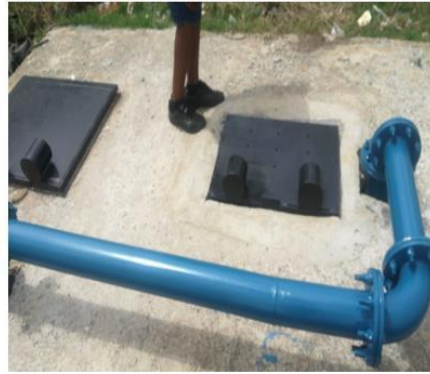
Only submersible pump currently not working

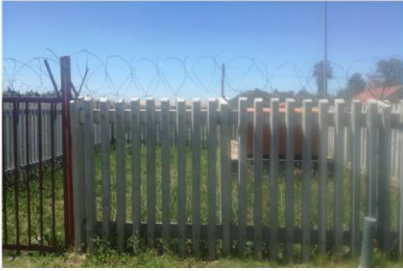
Overview of the pump station

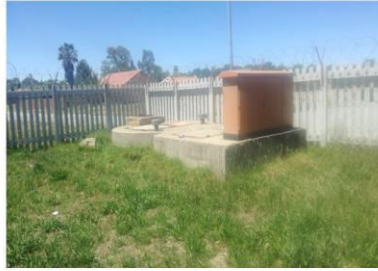
Temporary pumps inside the manholes working

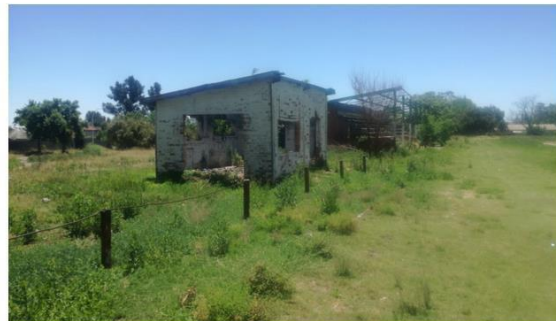
No proper fencing around the vandalised building

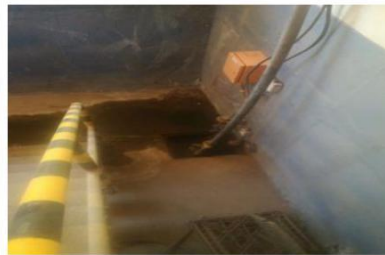
Sump pump, fully operational

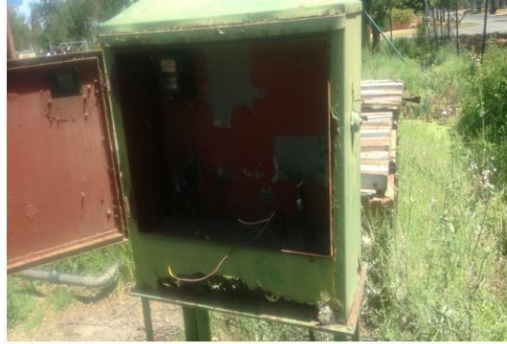
Vandalised switch box for booster pumps

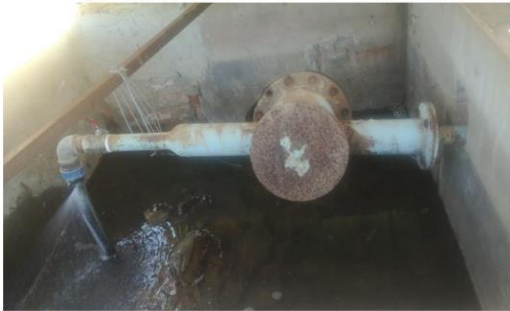
Pump not operating

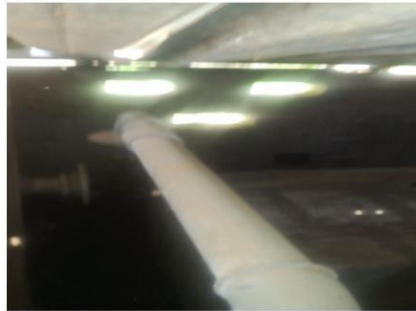
No motors, pump stolen and vandalised

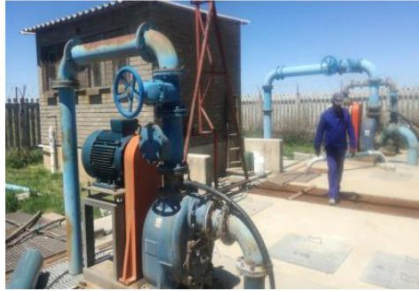
No power supply, no clean water and no sewer

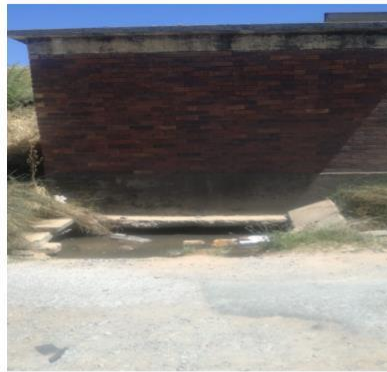
Side view, station vandalised

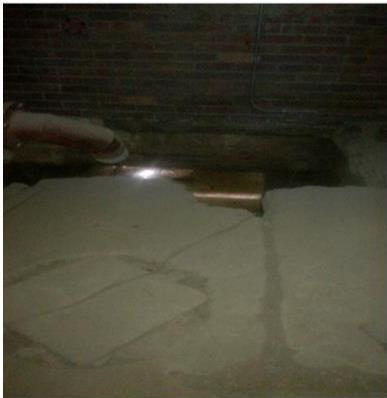
No pumps and DBS.

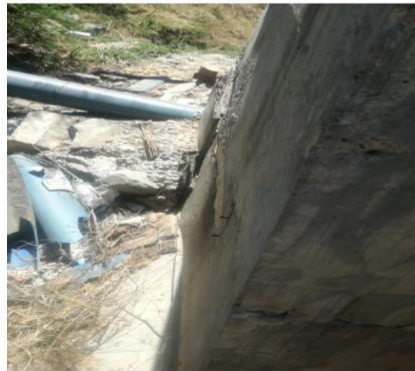
Vandalised not working

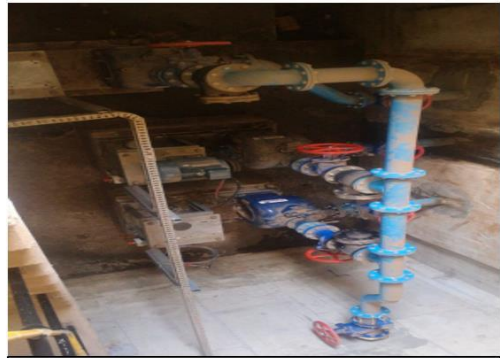
1/3 pump working, the other two pumps are not working, no motors and rotation assemblies

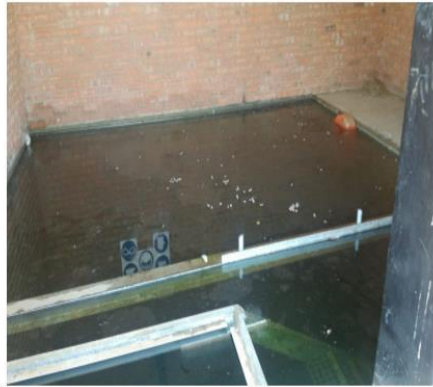
Sumps

Inside it is full of water and no pumps

11	Hanipark Pump Station	Hani Park	No pumps in this station. Lots of flooding in the facility	None	None	2 guards per shift	<ul style="list-style-type: none"> <li>Repairs of pumps with motors</li> <li>Electrical panel</li> <li>Construction of guard house with abluion facilities</li> <li>Placing of security personnel</li> <li>Installation of security fence</li> </ul>

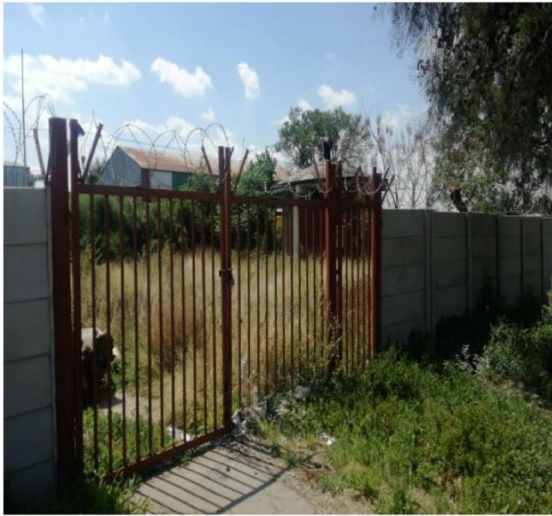
Power weg pump station

Not operating and no access

7	Power Road Pump Station	Industrial Area	Pump station not operating	No toilet on site	No guard house	No security	<ul style="list-style-type: none"> <li>Repairs of pumps</li> <li>Construction of guard house with abluion facilities</li> <li>Placing of security personnel</li> <li>Installation of security fence with sensors connected to alarm system</li> </ul>

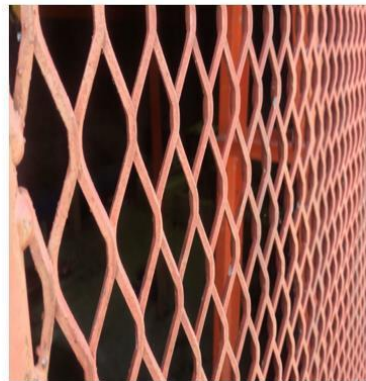
No key, no pumps inside. Contractor to do refurbishment on this Pump station

NUMBER	NAME OF PUMP STATION	LOCATION	FUNCTIONALITY	ABLUTION FACILITIES	GUARD HOUSE	SECURITY	RECOMMENDATION
8	Klippan Pump Station	Witpan	No pumps in this station, lots of flooding in the facility	None	None	1 Guard per shift	<ul style="list-style-type: none"> <li>Installation of security fence with sensors connected to alarm system</li> <li>Armed response</li> <li>Installation of security lights</li> </ul>
9	Bronville North Pump Station	Bronville	There are 3 pumps, only one is currently working	No Toilets on side	Construction of guard house with abluion facilities completed	Security On side (MBV no security on side due to non-payments)	<ul style="list-style-type: none"> <li>Installation of security fence with sensors connected to alarm system</li> <li>Armed response</li> <li>Installation of security lights</li> <li>Grass cutting around the pump station</li> </ul>
10	Bronville South Pump Station	Bronville	There are 3 pumps and only one is working	None	Construction of guard house with abluion facilities completed	Security On side (MBV no security on side due to non-payments)	<ul style="list-style-type: none"> <li>Installation of security fence with sensors connected to alarm system</li> <li>Armed response</li> <li>Installation of security lights</li> <li>Grass cutting around the pump station</li> </ul>

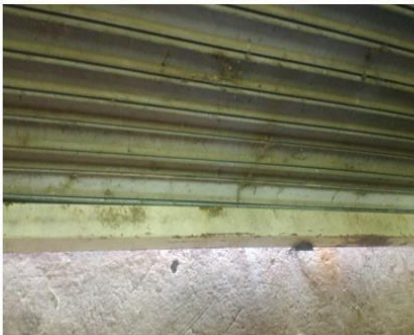
Thieves lift the roller door to gain access into the station

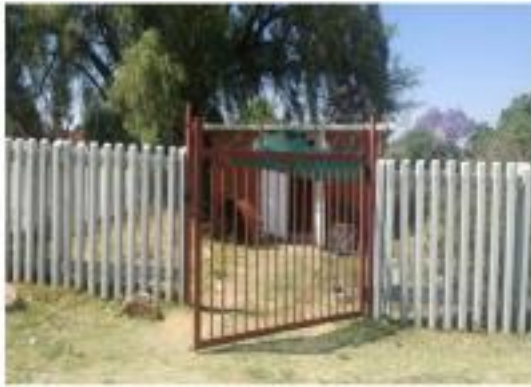
Rheederpark pump station

NAME OF PUMP STATION		Rheederpark Pumpstation			
ADDRESS/LOCATION		Welkom			
COORDINATES		27°56'39.37"S	26°43'3.70"E		
	<b>Drainage Area</b>	<b>Stands</b>	<b>Inflow in MI</b>	<b>Flow direction</b>	<b>Condition</b>
DRAINAGE AREA	Rheederspark	649	0.277	North Part of Rheederspark to Major	One out of 3 pumps currently operating
	<b>Description</b>				<b>Condition</b>
INFRASTRUCTURE	Structural works				Poor
	AblutionFacilities				None
	Drinking water				None
	Fenced				Yes
	Lockable Gate				No gate
	Electrical Supply				Yes
	<b>Description</b>	<b>Number</b>	<b>Condition</b>		
PUMP STATION COMPONENTS	Submersible pump				
	Number of Pumps		3 2 not working		
	Sump pump		1 Good		
	Extraction Fan		None		
	Auto Rake		None		
	Screen press		None		
	Muffle monster		None		
	Motors		3 1 working		
	Starter		None		
	Ultrasoninc		None		
	Flow Meter		None		
	Generator		1 Good

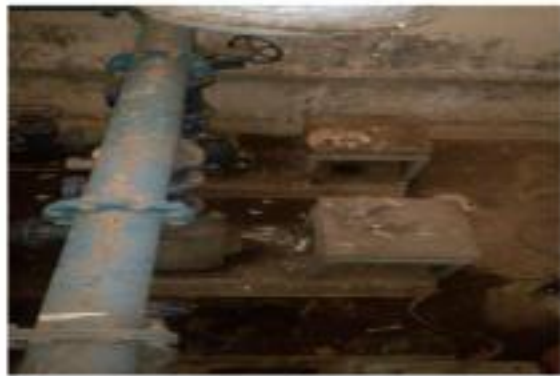
2 pumps not working, no rotation assemblies and motors

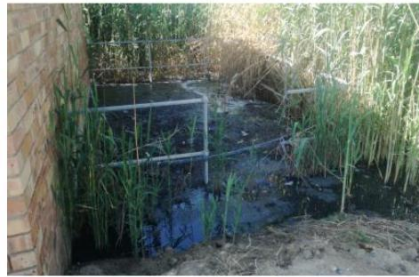
Pump station sumps not working

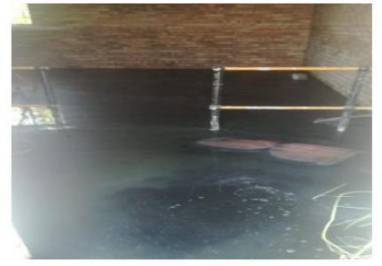
Flooding inside the pump station

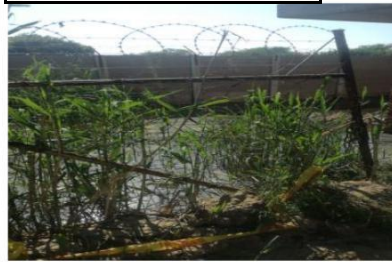
Lots of flooding, pump station not working

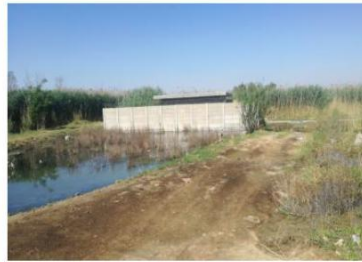
Lots of cable theft has occurred here
