# **INFRASTRUCTURE MASTER PLAN 2019-2029**

## **PHASE 1 (WATER AND SANITATION)**

**MATJHABENG LOCAL MUNICIPALITY**

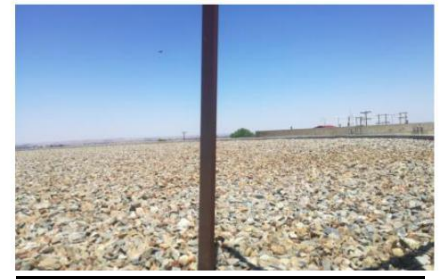
Top view brabandt1, no issues

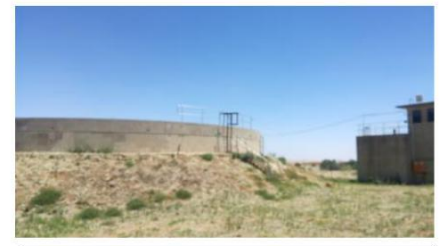
Brabandt2, no issues

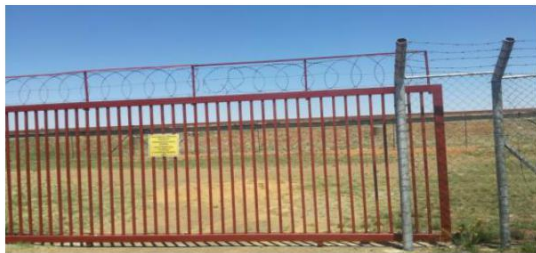
Key changed, no access

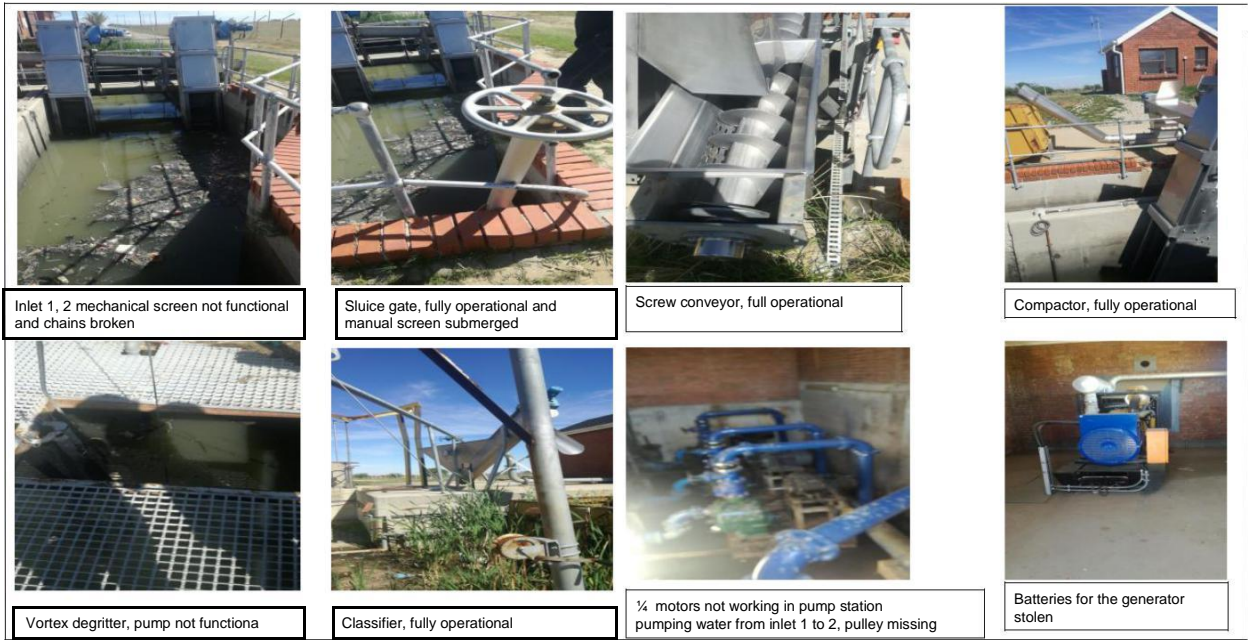
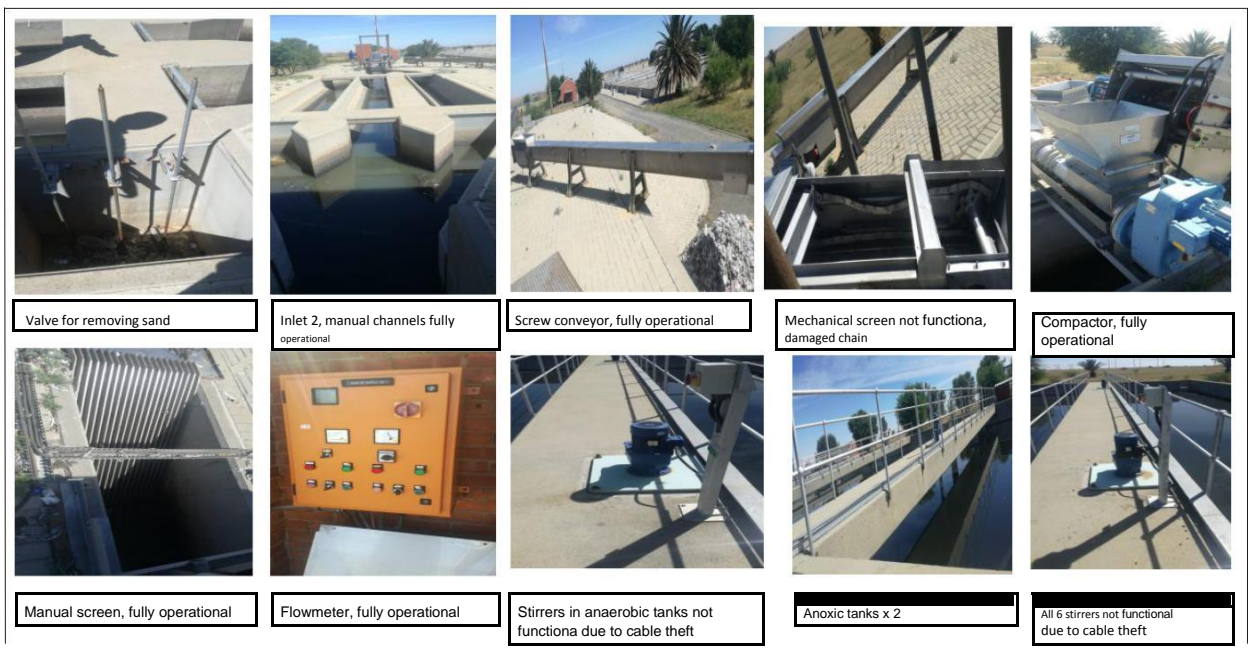
Kutlwanong WWTW

Activated sludge		Y	2	ok
		Rotating biological contactors		Y	2	Stirrers in anarobic tanks not working due to cable theft
		Secondary Settler	humus tank clarifier	Y	2	
5	TERTIARY TREATMENT PROCESS	Disinfection (chemicl/UV)		Y	1	ok
		Constructed Wetlands		N		
		Maturation pond/s				
6	SLUDGE TREATMENT PROCESS		filter/belt press	Y	1	ok
			drying beds	Y	6	ok
		Dewatering	gravity	N		
			dissolved air floatation	N		
		Thickening		N		
		Digestion				
7	FACILITY FACILITIES	Fence (steel pallisade (SP)/fence/concrete palisade(CP)/ brick wall (BW)/wire fence		Y		Electrical Fence ,not working
		Lockable gate		N		Bad,no lockable gates
		Electrified		Y		Electrical Fence ,not working
		Yard		Y		In good condition
		Staff facilities		Y		In good condition
		Sludge licence		Y		
8	REMARKS	Contract for sludge disposal		Y		
		Plant is about 30% operational mainly due to the cable theft and vandalism

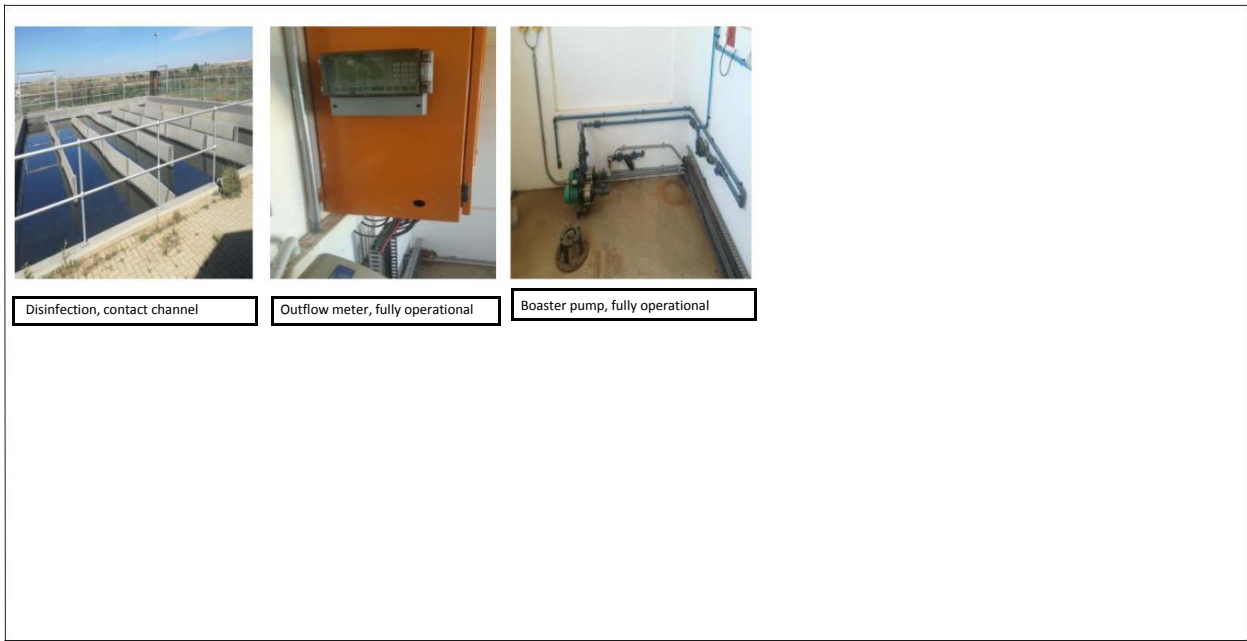
Kutwanong WWTW (continued)

Disinfection, contact channel

Outflow meter, fully operational

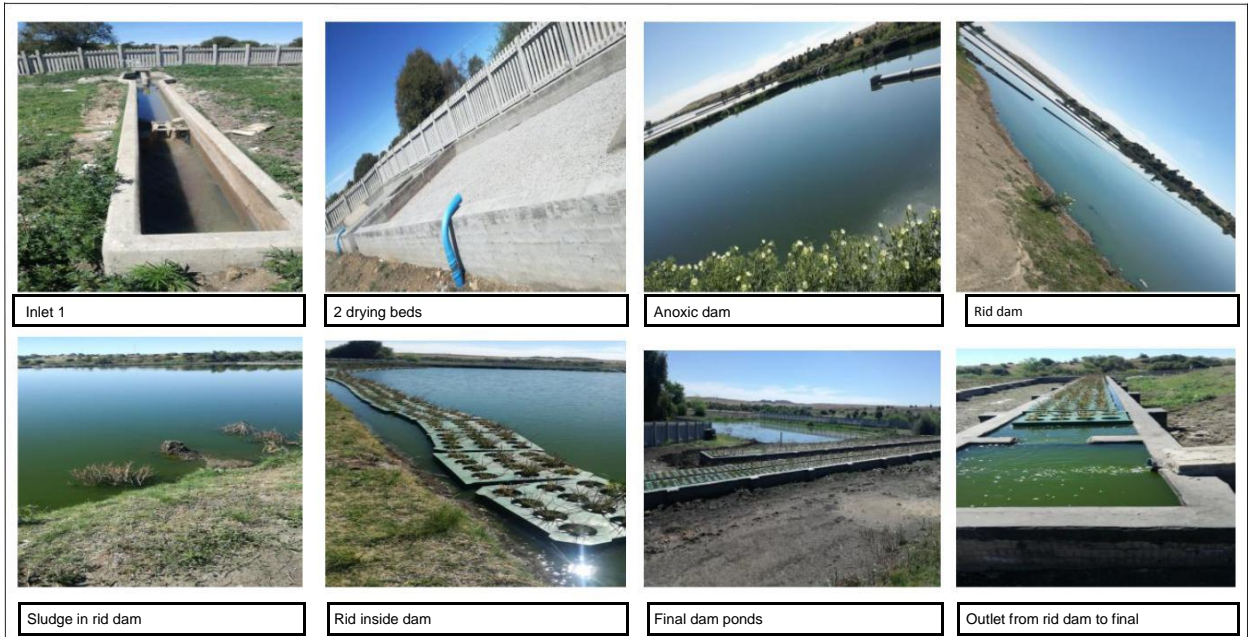
Mmamahabane WWTW

Lockable gate	N		Bad,no lockable gates	
		Electrified	N			
		Yard	Y		In bad condition	
		Staff facilities	Y		In bad condition	
		Sludge licence	N			
		Contract for sludge disposal	N			
8	REMARKS	Plant is operating and consists of Anoxic dam and Rid dam

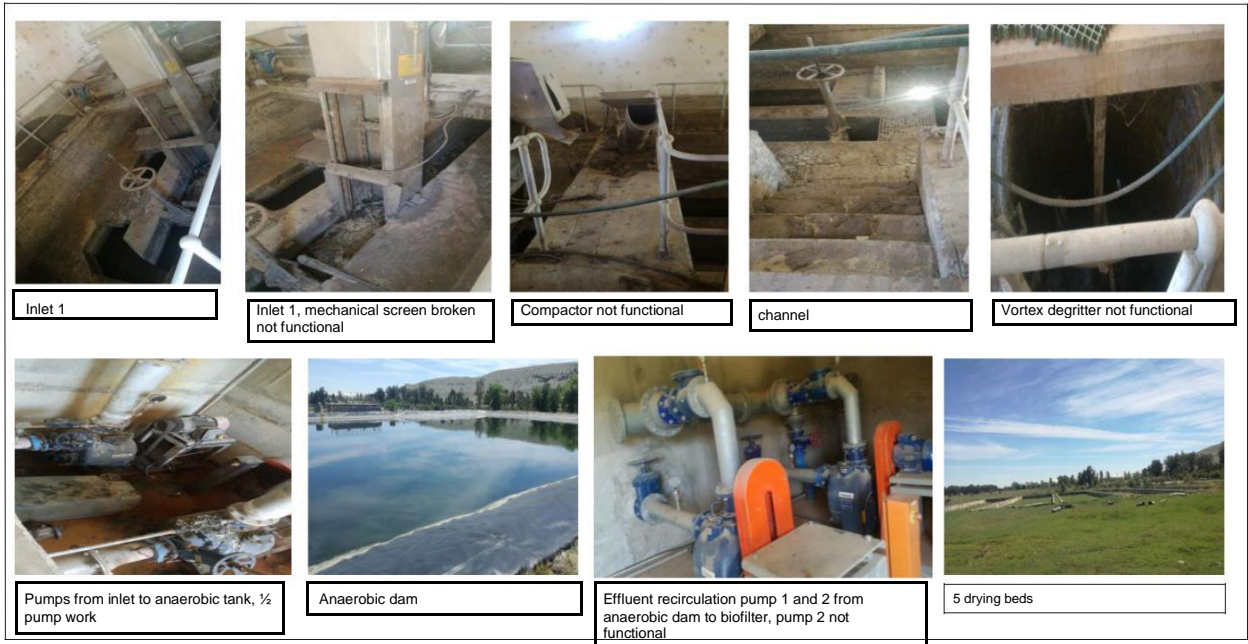
Odendaal WWTW

dissolved air floatation	N		
		Digestion	Y	1	Bad,not working	
7	FACILITY FACILITIES	Fence (steel pallisade (SP)fence/concrete palisade(CP)/ brick wall (BW)/wire fence)	Y		Concrete palisade,completely vandalised by Zamazamas	
		Lockable gate	N		Bad,no lockable gates	
		Electrified	N			
		Yard	Y		In bad condition	
		Staff facilities	Y		In bad condition	
		Sludge licence	N			
		Contract for sludge disposal	N			
8	REMARKS	This plant is about 30% operational with most componets not functioning because they are broken/vandalised and need to be replaced.

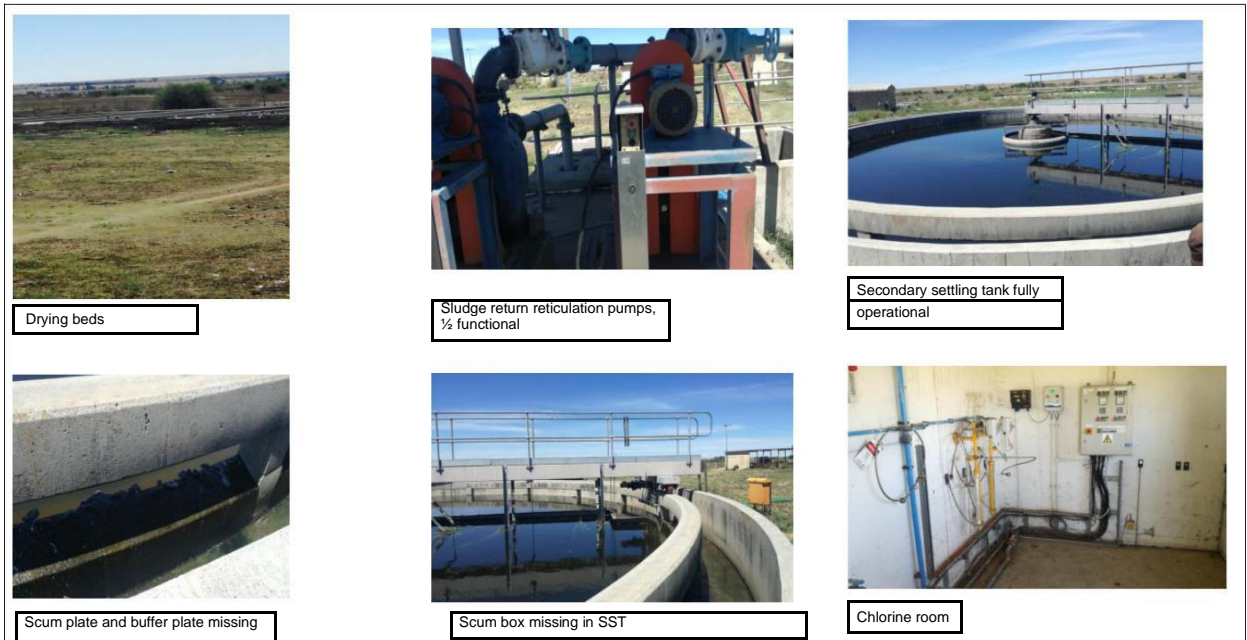
Phomolong WWTW (continued)

Chlorine tank missing, booster pump stolen, still waiting for the order.

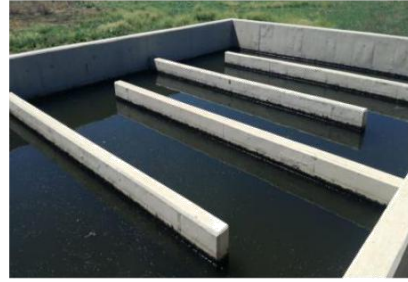
Chlorine tank

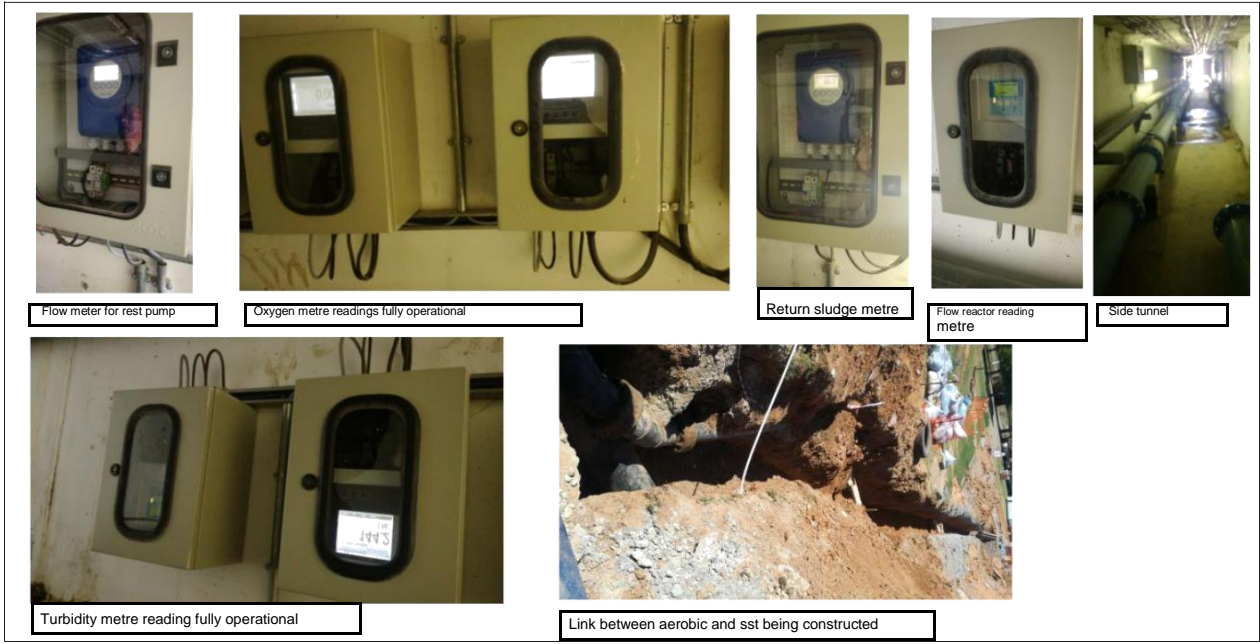
Flow meter for rest pump

Oxygen metre readings fully operational

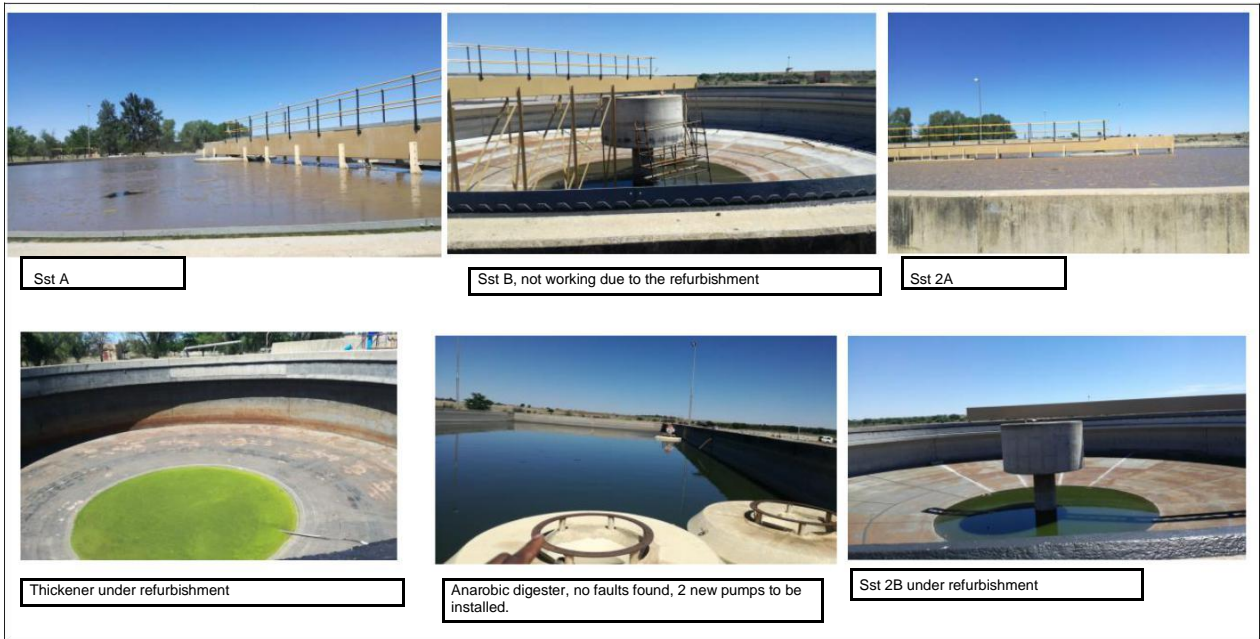
Sst A

Sst B, not working due to the refurbishment

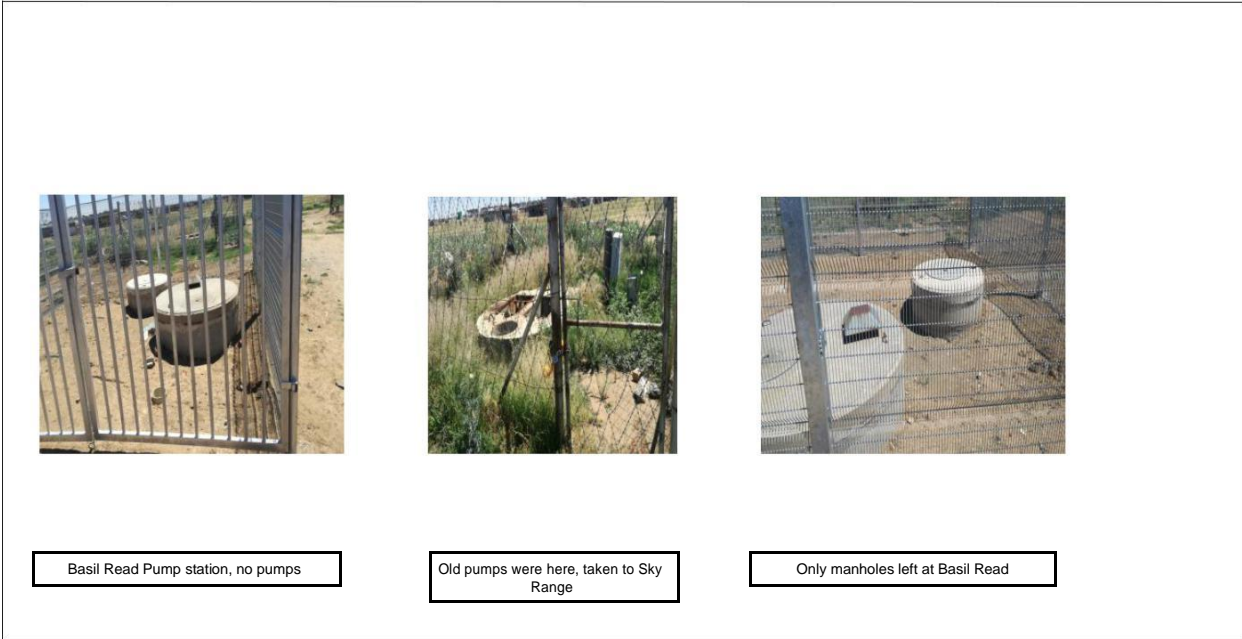
Basil Read Pump station, no pumps

Old pumps were here, taken to Sky Range

To be decommi ssioned.

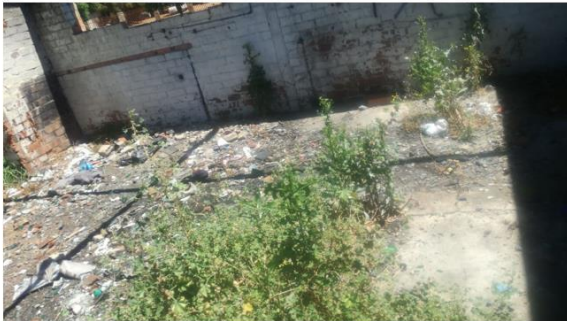
Nothing inside the vandalised building

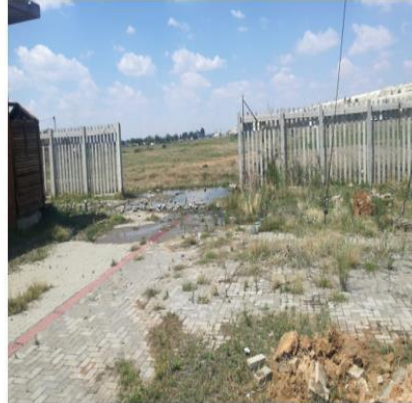
No gate

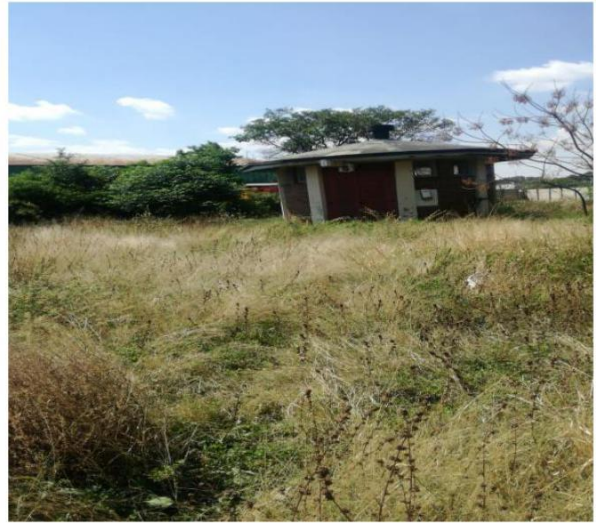
Power weg pump station

Not operating and no access

7	Power Road Pump Station	Industrial Area	Pump station not operating	No toilet on site	No guard house	No security	<ul style="list-style-type: none"> <li>Repairs of pumps</li> <li>Construction of guard house with abluion facilities</li> <li>Placing of security personnel</li> <li>Installation of security fence with sensors connected to alarm system</li> </ul>

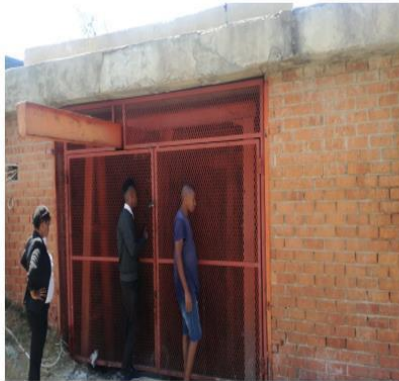
Klippan Pumpstation currently not working

NUMBER	NAME OF PUMP STATION	LOCATION	FUNCTIONALITY	ABLUTION FACILITIES	GUARD HOUSE	SECURITY	RECOMMENDATION
8	Klippan Pump Station	Witpan	No pumps in this station, lots of flooding in the facility	None	None	1 Guard per shift	<ul style="list-style-type: none"> <li>Installation of security fence with sensors connected to alarm system</li> <li>Armed response</li> <li>Installation of security lights</li> </ul>
9	Bronville North Pump Station	Bronville	There are 3 pumps, only one is currently working	No Toilets on side	Construction of guard house with abluion facilities completed	Security On side (MBV no security on side due to non-payments)	<ul style="list-style-type: none"> <li>Installation of security fence with sensors connected to alarm system</li> <li>Armed response</li> <li>Installation of security lights</li> <li>Grass cutting around the pump station</li> </ul>
10	Bronville South Pump Station	Bronville	There are 3 pumps and only one is working	None	Construction of guard house with abluion facilities completed	Security On side (MBV no security on side due to non-payments)	<ul style="list-style-type: none"> <li>Installation of security fence with sensors connected to alarm system</li> <li>Armed response</li> <li>Installation of security lights</li> <li>Grass cutting around the pump station</li> </ul>

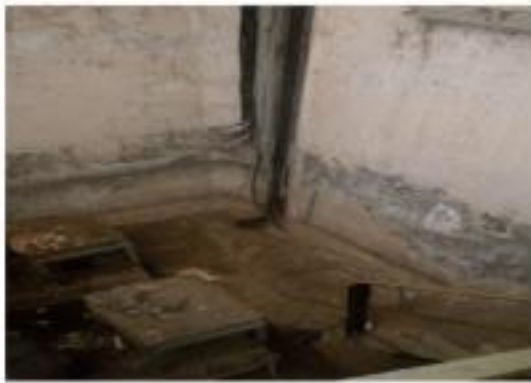
Cable theft

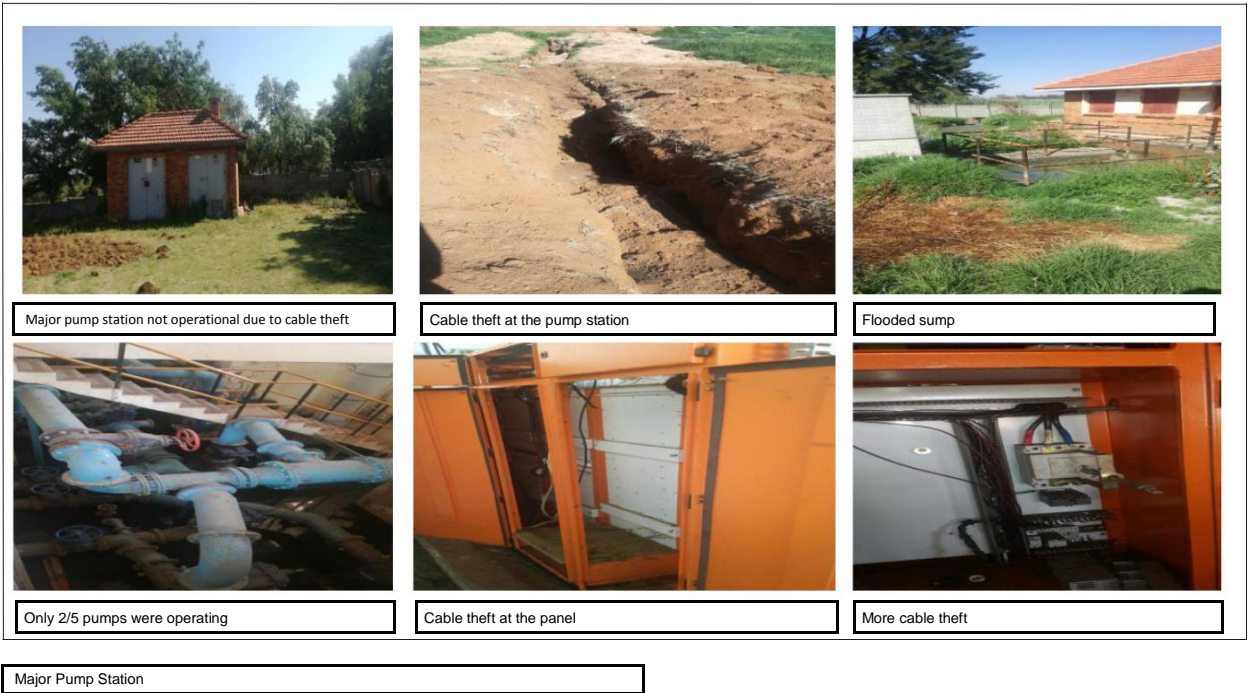
## Major Pump Station Condition Assessment Pictures

NAME OF PUMP STATION		Major Pumpstation			
ADDRESS/LOCATION		Welkom			
COORDINATES		27°59'38.28"S	26°42'16.05"E		
	<b>Drainage Area</b>	<b>Stands</b>	<b>Inflow in MI</b>	<b>Flow direction</b>	<b>Condition</b>
DRAINAGE AREA	Major	2164	0.949	Collects from the Southern part of Welkom, Verkeer, Power Road, Rhedeers Park, Phomolong Village and Western pump station and pump into the Theronia WWTW	The pumpstation is currently not working mainly due to cable theft.
	<b>Description</b>				<b>Condition</b>
INFRASTRUCTURE	Structural works				Poor
	Ablution Facilities				None
	Drinking water				None
	Fenced				Yes
	Lockable Gate				No gate
	Electrical Supply				Yes
	<b>Description</b>	<b>Number</b>	<b>Condition</b>		
PUMP STATION COMPONENTS	Submersible pump				
	Number of Pumps	5	All not working		
	Sump pump	0			
	Extraction Fan		None		
	Auto Rake		None		
	Screen press		None		
	Muffle monster		None		
	Motors		None		
	Starter		None

NUMBER	NAME OF PUMP STATION	LOCATION	FUNCTIONALITY	ABLUTION FACILITIES	GUARD HOUSE	SECURITY	RECOMMENDATION
5	Major Pump Station	St. Helena	The pump station is currently not working mainly due to cable theft	No toilet on site	guard completed	Security On side (MBV not on side due to non-payments) Needs armed response	<ul style="list-style-type: none"> <li>Repairs of pumps, repair panel</li> <li>Installation of security fence with sensors connected to alarm system</li> <li>Armed response</li> <li>Installation of security lights</li> <li>Grass cutting around the pump station</li> </ul>
6	Old Traffic Pump Station	Doorn	There are 3 pumps and only 1 is currently working  Pump station Needs to be refurbished. Challenges with sand entering the pump station.	There is toilet on site	No guardhouse To be build	No security	<ul style="list-style-type: none"> <li>Repairs of 2 pumps</li> <li>Construction of guard house with abluion facilities</li> <li>Placing of security personnel</li> <li>Installation of security fence with sensors connected to alarm system</li> <li>Armed response</li> <li>Installation of security lights</li> <li>Grass cutting around the pump station</li> </ul>

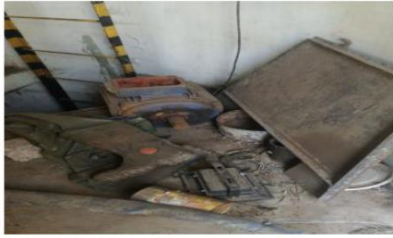
Old motors

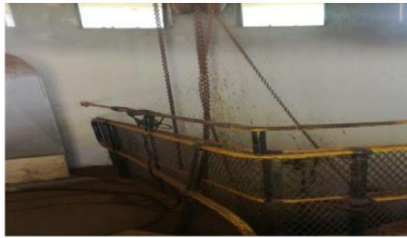
Old motors
